REPORT OF CONCRETE TESTING

LVMPD EVENTS #040215-1500

APS JOB NO: 10-03088

DATE: MAY 5, 2004

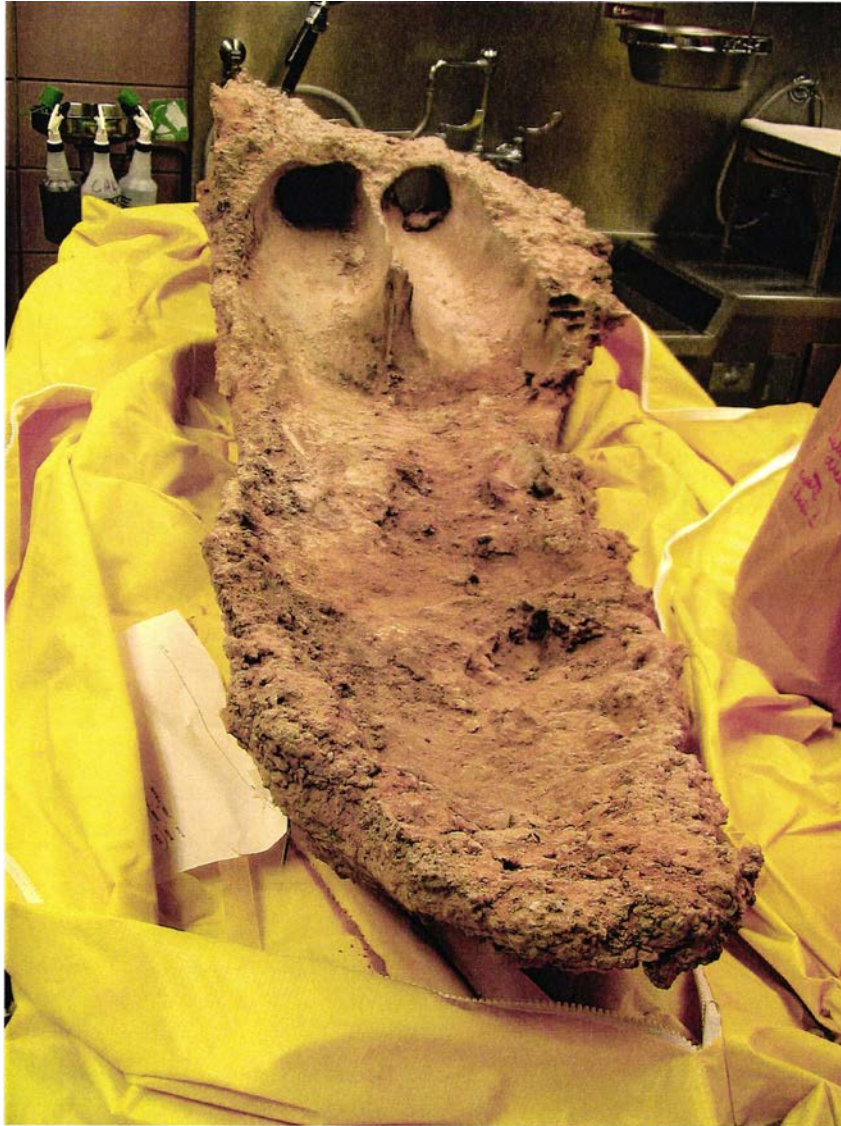
The bottom of the grave contained a stiff concrete mixture identified as placement #1.

The first section of concrete examined was from the bottom of the grave down the length of the grave (approximately 6 feet) with a maximum thickness of roughly 6 inches and was identified as placement #1. This concrete contained numerous consolidation voids on the surface that the body was laid onto. The mixture appeared to have been placed with a low slump or was beginning to dry out and set up. There were clear depressions where the head, shoulders and back had been in contact with the concrete. This surface did not conform well at all with the backside of the body preserving very little surface detail. In the area of the back of the head we observed intermittent black hair fibers adhered to the cement paste.

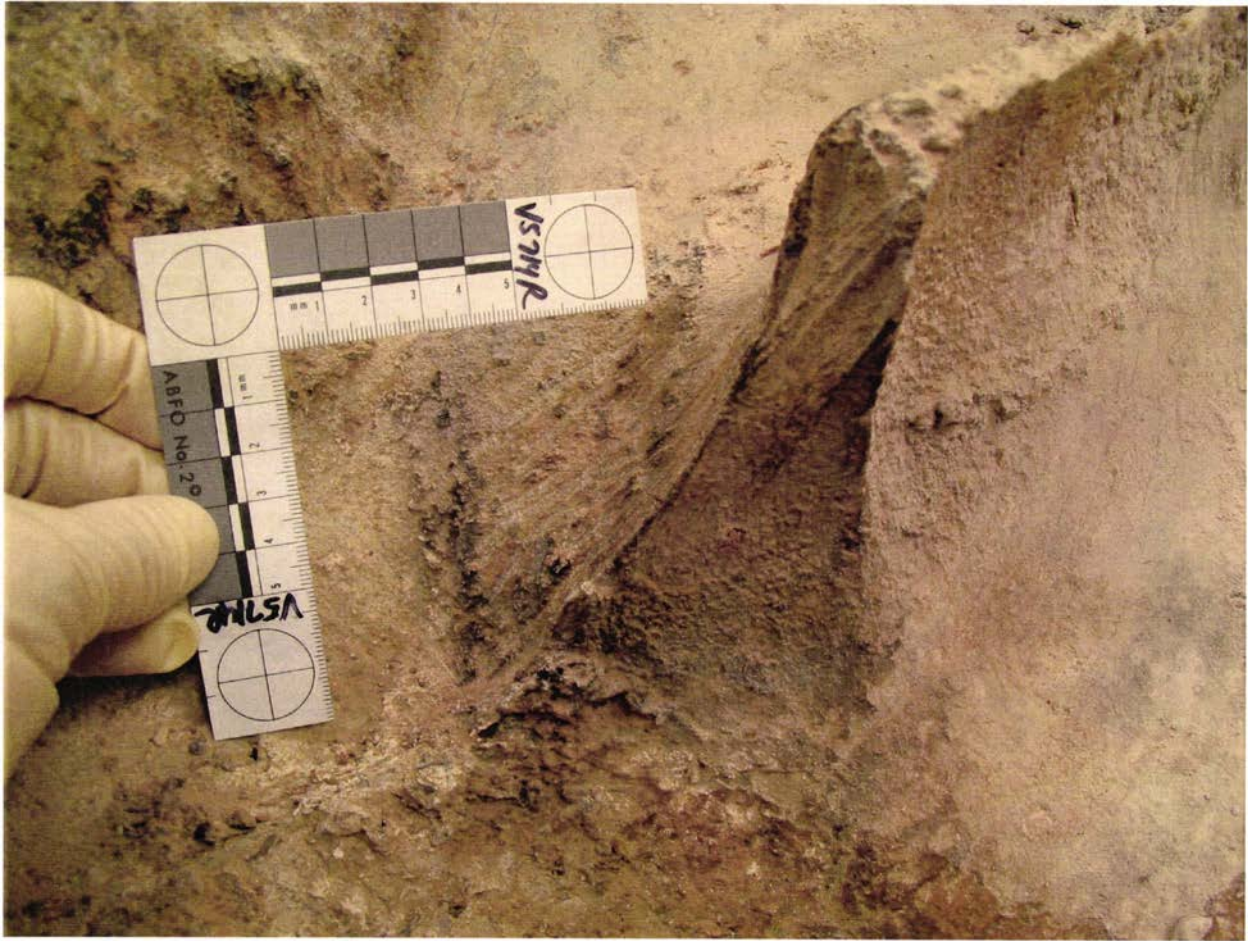
A cold joint contact between placements #1 & 2 runs roughly along the area at the bottom of the buttocks region of the victim. The higher slump of placement #2 molded perfectly around the legs as well as in the areas between the legs. Skin folds in the vagina and the texture of the skin was preserved in the paste of placement #2.

In the area of the lower buttocks a pronounced change in the consistency of the concrete was observed, a cold joint, indicating the contact between two separate placements. This concrete, identified as placement #2, contained very few voids and molded very well with all observable surfaces of the lower portions of the body. This indicates the second concrete placement was of a higher slump and more fluid. The fact that the underside of the legs had molded perfectly indicates the more fluid material was able to flow around the legs and occupy all void-space. A prominent, thin ridge (approximately 5" high by $\frac{3}{4}$ " thick) of hardened cement paste was observed where the paste flowed between the legs of the victim. Folds of skin in the area of the vagina were imbedded in the ridge along with numerous pubic hair fibers observed.

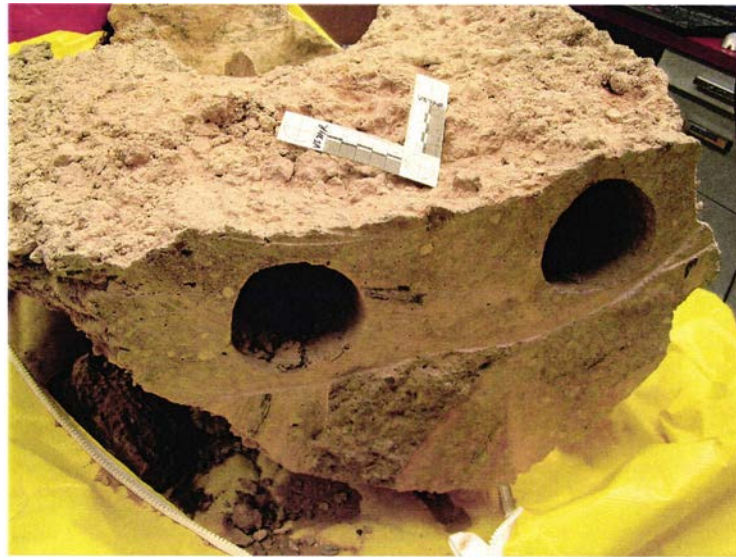
The lower leg area of the concrete mass was cut off exposing a crushed carbonate coarse aggregate in placement #2. The mixture looked well distributed and consistent with a processed material.

On the feet end of the grave, the placement #2 concrete was approximately 8" thick and exhibited a relatively flat top surface that was consistent with a higher slump concrete. An approximately 20" long section at the feet of the concrete mass had been cut off by the Las Vegas Fire Department with a concrete cut-off saw. Upon wetting the cut surface of placement #2, we observed relatively well distributed, crushed carbonate and sand aggregate within a medium to light gray cement paste matrix.

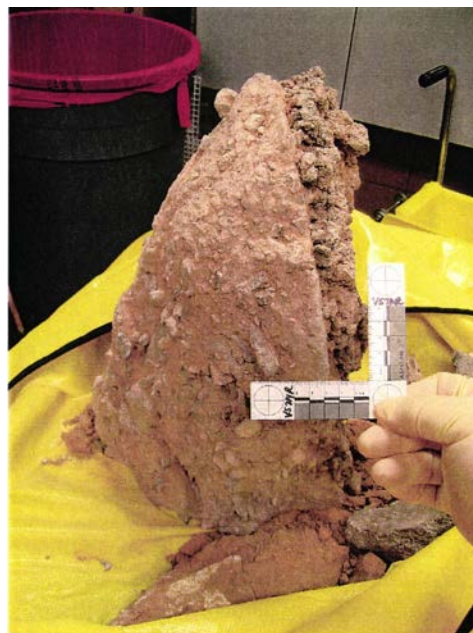
The feet end of placement #2 was cut off and exhibited a flat top surface indicating a higher slump. On this surface, concrete rubble was observed that is consistent with a very low slump concrete representing a third placement.

On the relatively flat top surface of the placement #2 concrete we observed concrete rubble that appeared consistent with a very low slump concrete. The concrete rubble was adhered to the surface of placement #2 and appeared to represent material spread away from a third concrete placement.

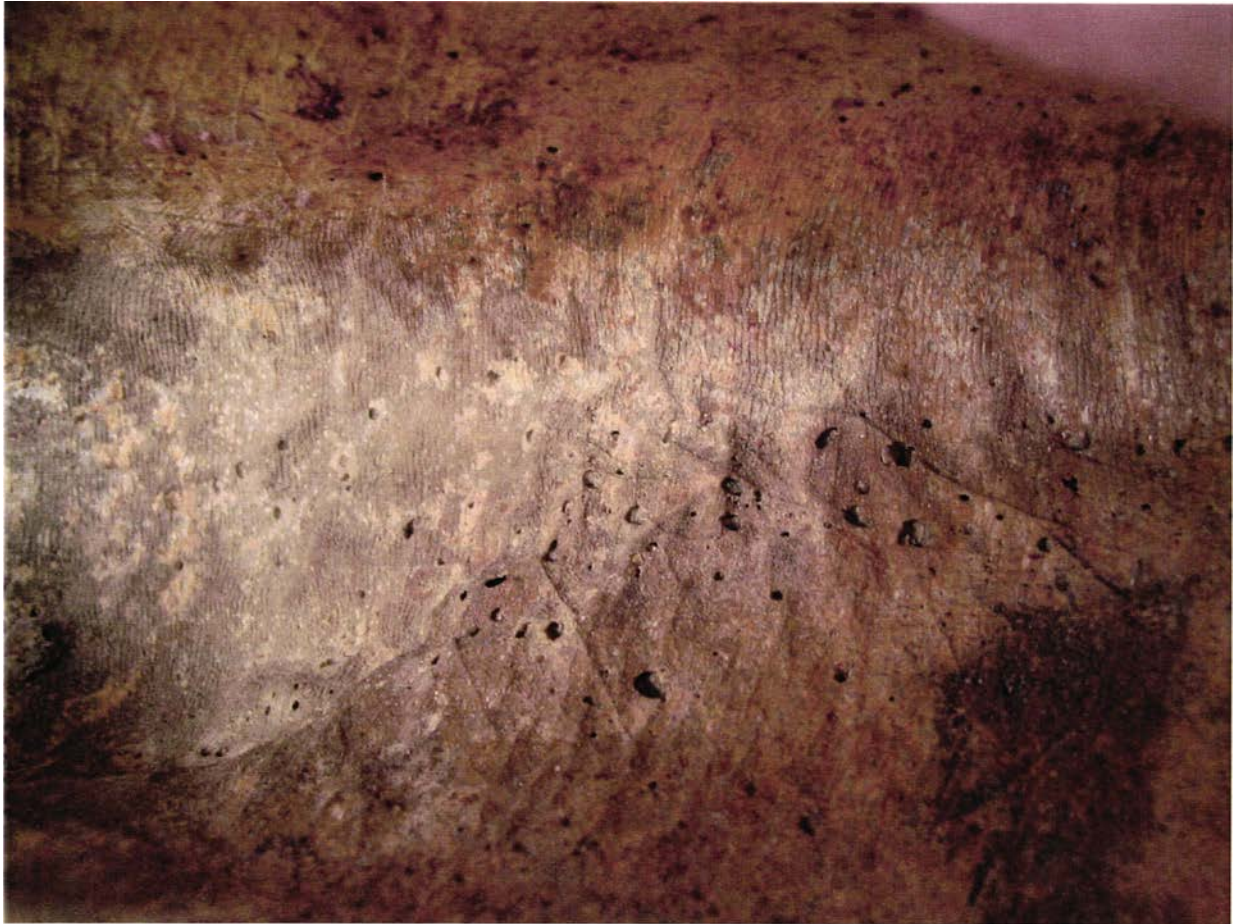
Prints from the bottom of the feet were preserved within the cement paste of placement #2.

The top portion of the cut off section of placement #2 was also cut into to expose the feet area of the victim. The entire skeleton of the victim had been removed exposing impressions of the skin within the cement paste. The preservation of textures of the skin was excellent which included perfect impressions of skin folds and prints on the bottom of the feet.

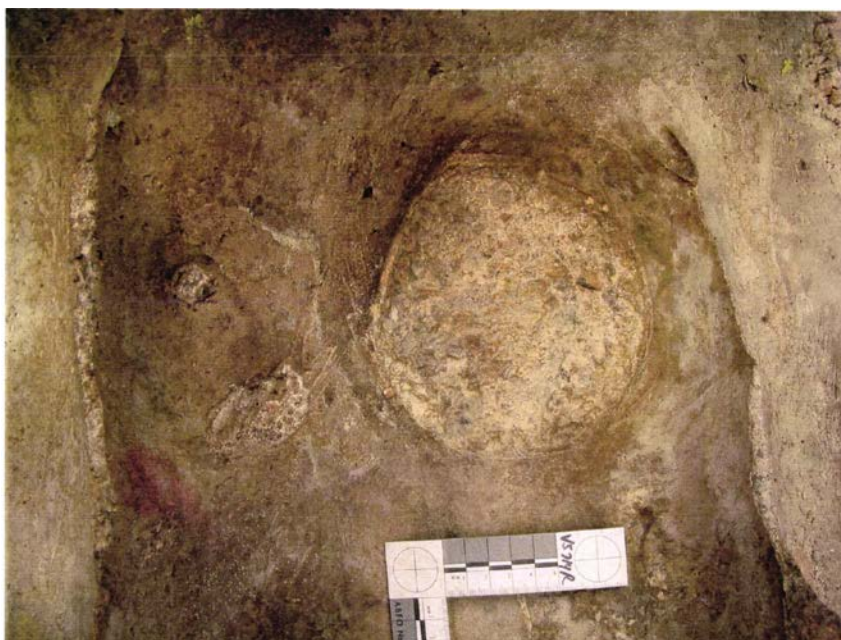
The breasts of the victim experienced severe trauma. A portion of the lower left breast was cut out and the nipple had apparently been bitten off. The entire right breast was cut off.

Multiple wounds were also preserved in the concrete and have shed light on the type of killer who committed this crime. The left breast had been cut off from the victim's body. The right breast had numerous cut marks and some missing flesh. The right nipple was missing with what appeared to be bite marks indicating that the nipple had been bitten off.

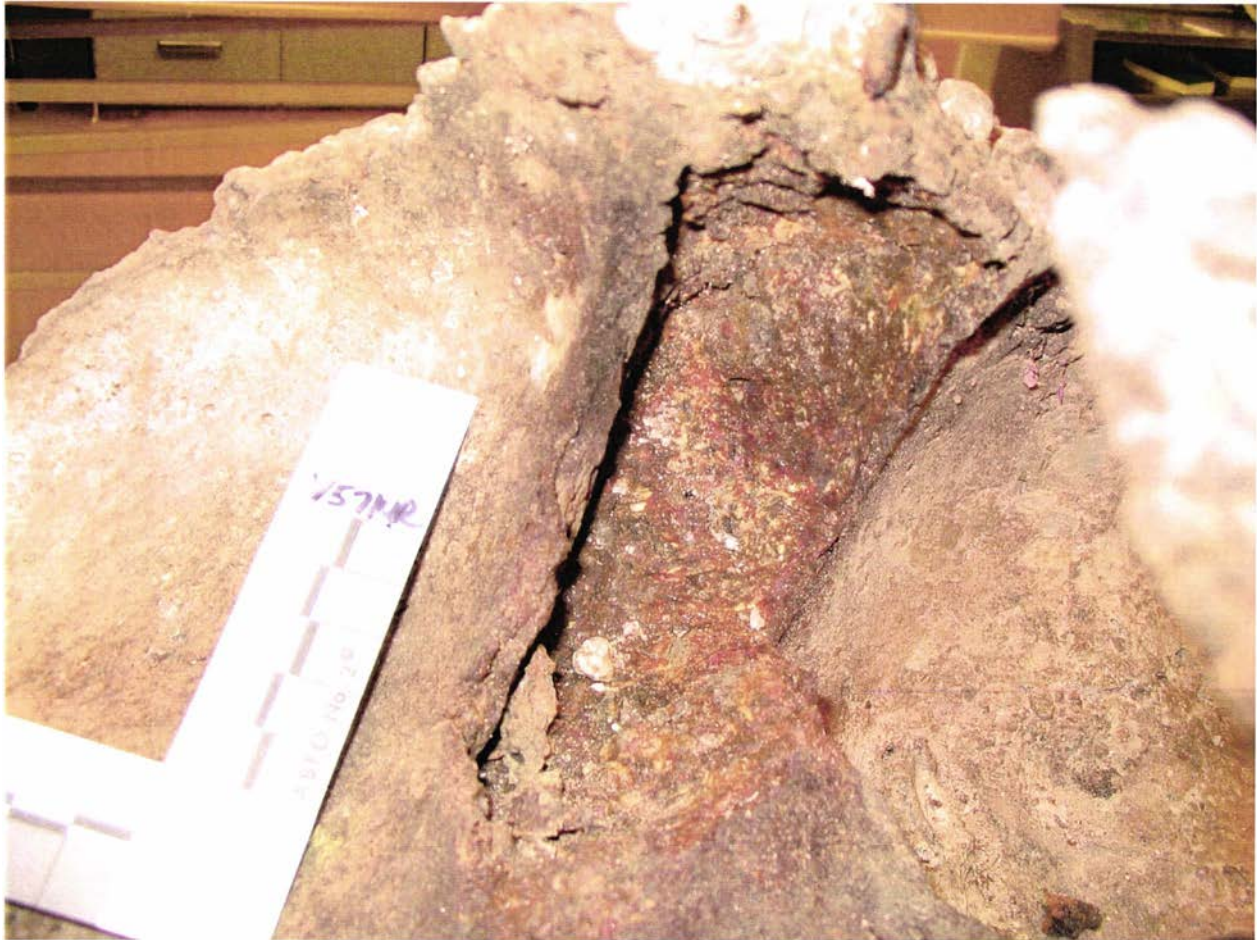
An unknown void was present in the area between the left shoulder and the head at right. The surface texture in the void was similar to the area of the missing breast suggesting it ended up here.

There was a rather large void in the area between the head and the left shoulder. A dark discoloration in the area adjacent to the void suggests that a chemical reaction occurred between the concrete and fluids from the body. The irregular surface texture within the void is similar to the surface texture in the area of the missing right breast. The mass could be the where the missing breast tissue went. The lack of skin texture in the void could mean the skin was removed from the breast.

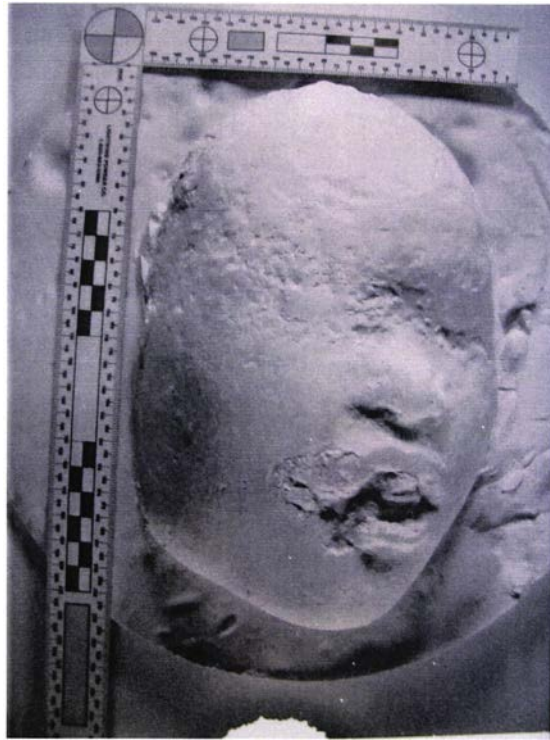
A mold of the head and face revealed a severe wound on the right side of the mouth and jaw suggesting the victim received a forceful impact.

A mold was made of the head of the victim, which revealed a wound on the right side of the mouth made from a forceful impact.

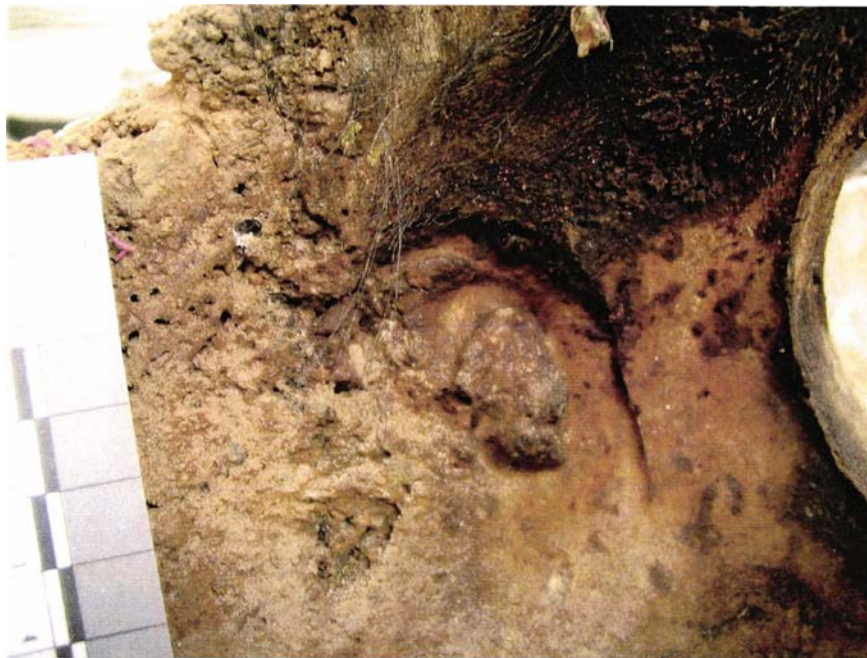
Preservation of the ear in the concrete allowed for making a mold, which might aid in identification of the victim.

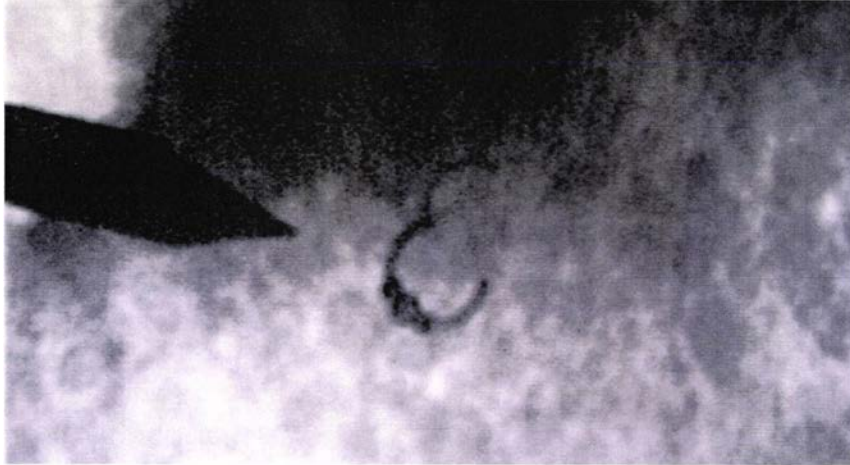
An x-ray of a section of concrete indicates the presence of an earring likely belonging to the victim.

After about 4 hours of examining the concrete, the case file was reviewed, which included about 200 photographs. The photos included aerial shots of the gravesite, processing of the crime scene, collection of evidence, the making of several molds, and x-ray photos of evidence within the concrete. The x-ray photos indicate that an earring and a body-piercing stud are present with the concrete.

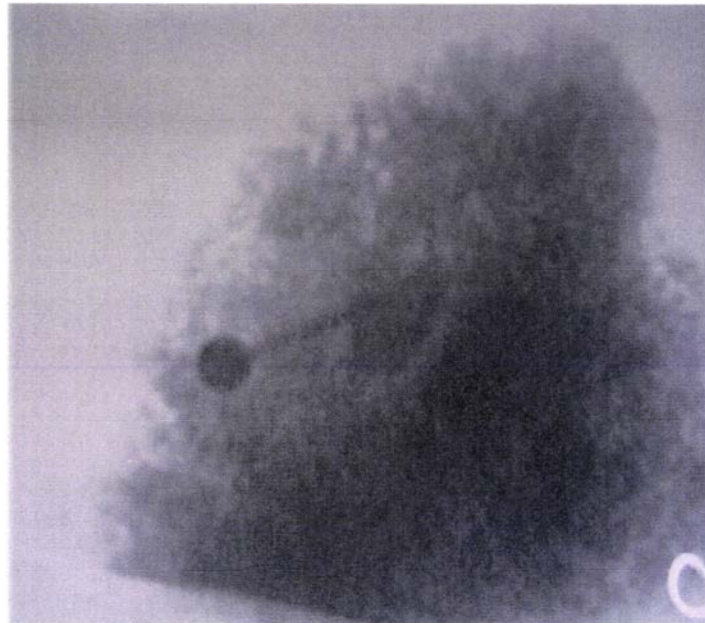
An x-ray of a section of concrete indicates the presence of a stud piercing likely belonging to the victim.

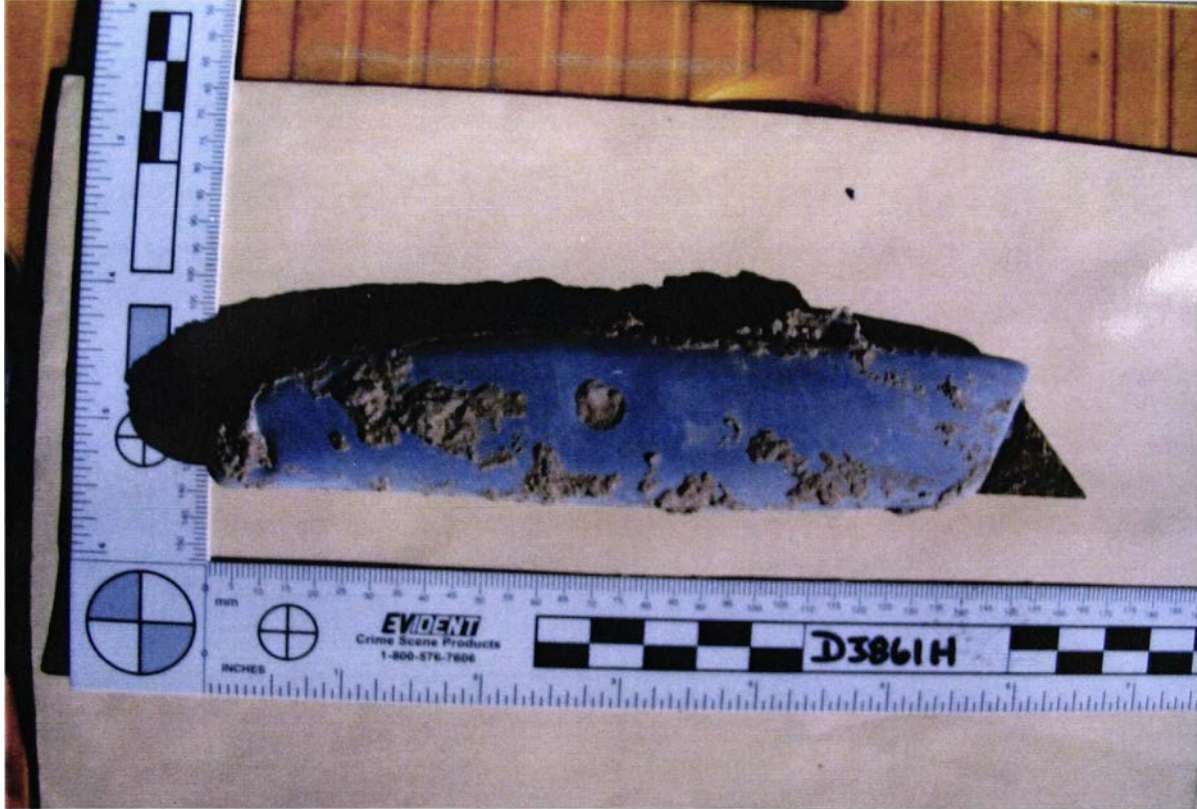
Concrete paste splatters were present on the handle of a box-cutter knife found a few feet from the grave.

5. The material adhered to the box-cutter knife is concrete. The concrete splatters on the knife are comprised of the same constituents as the concrete in the grave.

One important piece of evidence collected at the scene was a blue handled box-cutter knife that was found a few feet from the grave under a bush. Close-up photos of the box-cutter knife showed numerous concrete splatters on the knife. Examination of the splatters may be able to link the splatter, and the knife, to the concrete in the grave.

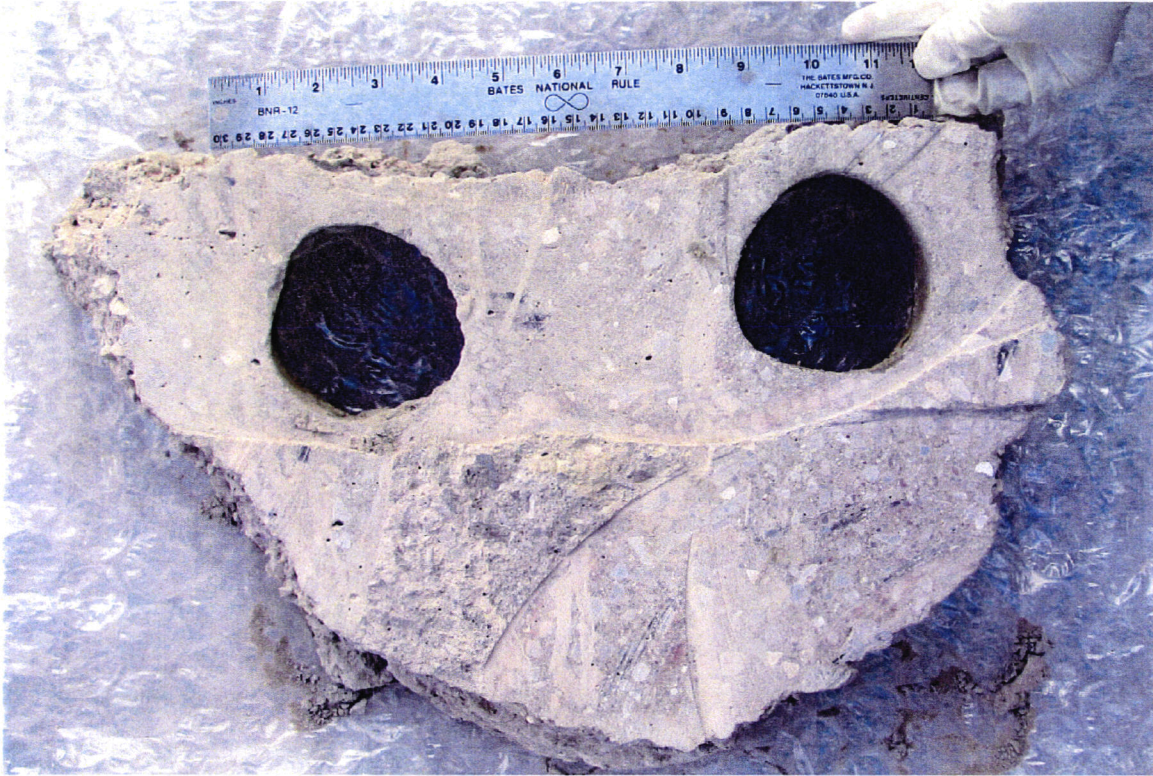
SAMPLE ID: P1-P2 DESCRIPTION: Sawcut section of concrete as recieved.

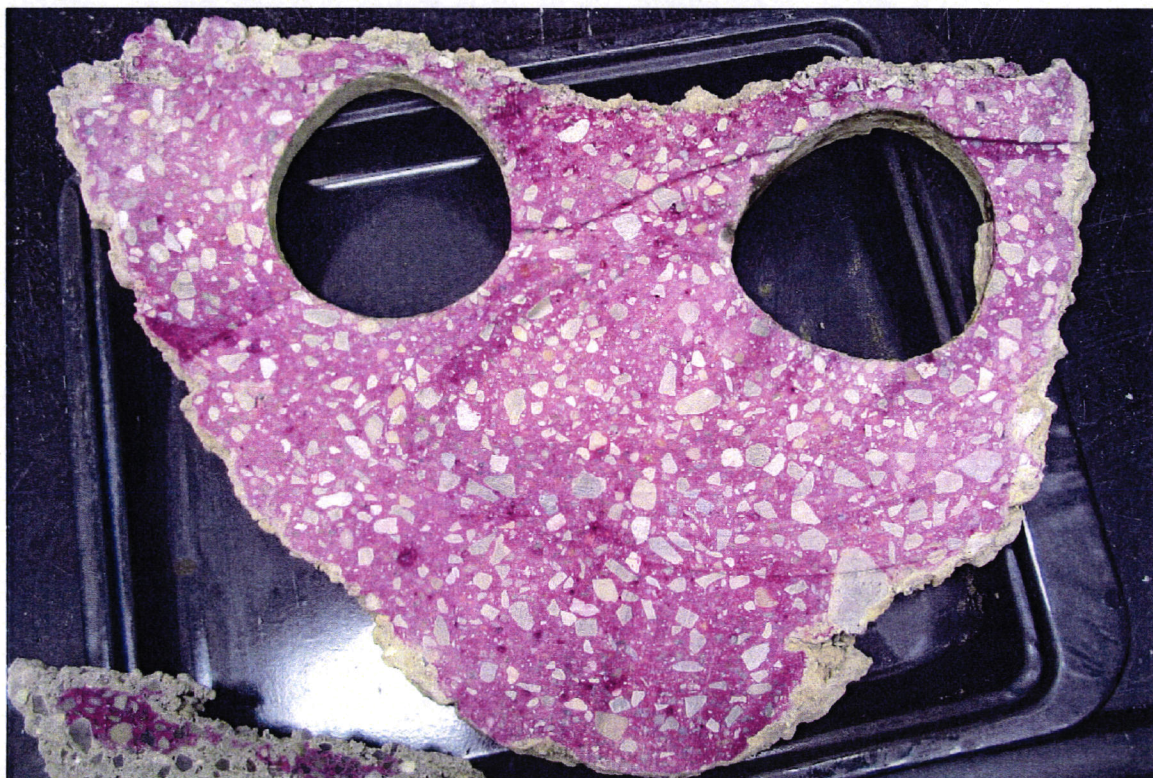
SAMPLE ID: P1-P2 DESCRIPTION: Carbonation (unstained) proceeds thinnly around the perimeter of the placement and leg impressions.

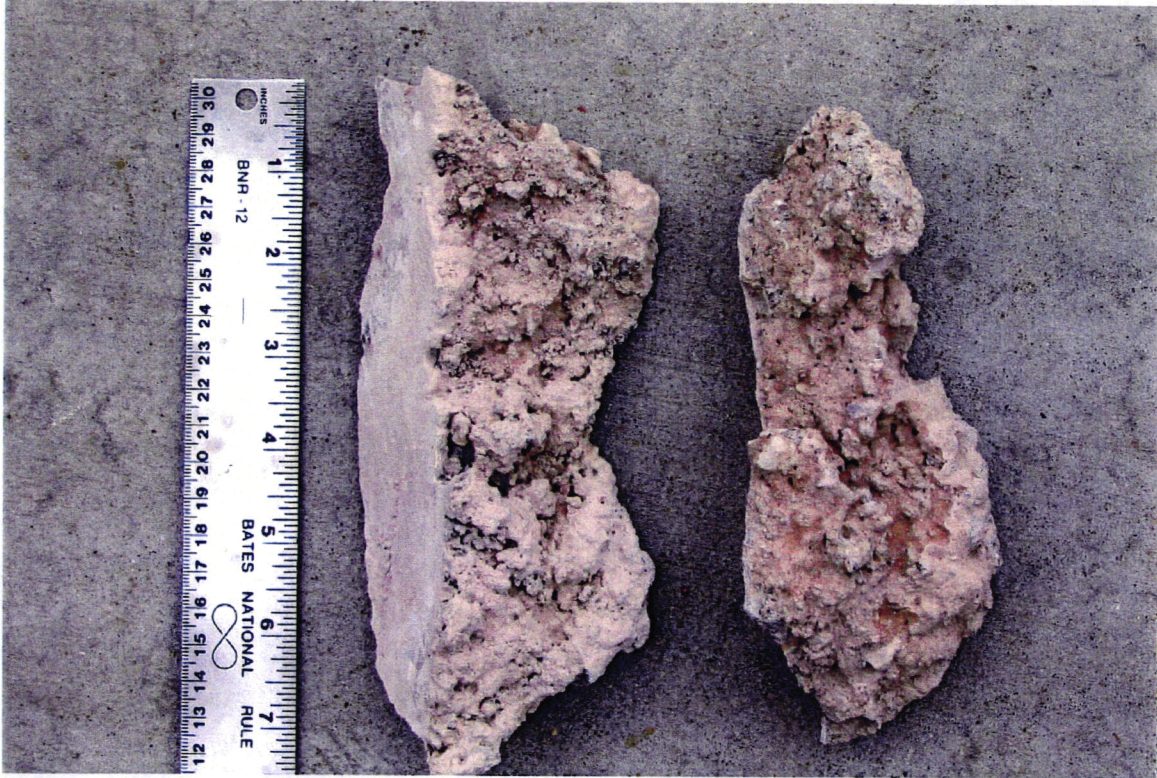
SAMPLE ID: P3 DESCRIPTION: Sawcut section of concrete as recieved.

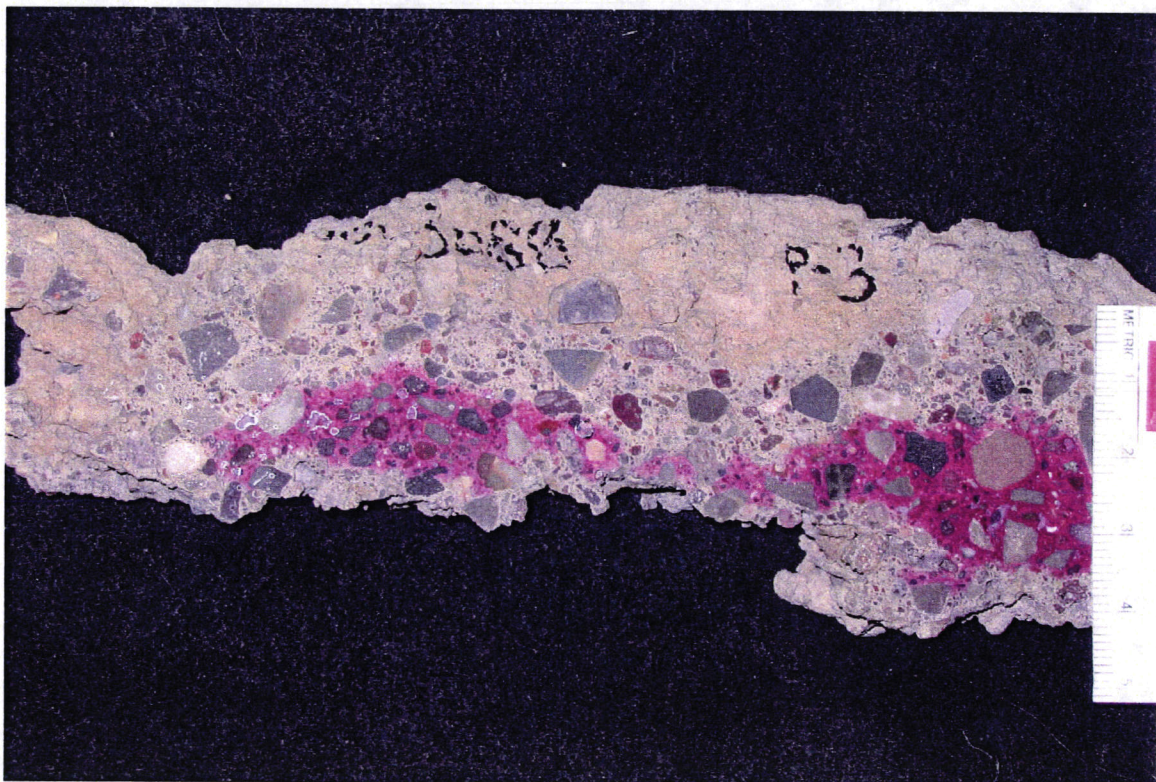
SAMPLE ID: P3 DESCRIPTION: Carbonation (unstained) proceeds deeply around the perimeter of the placement.

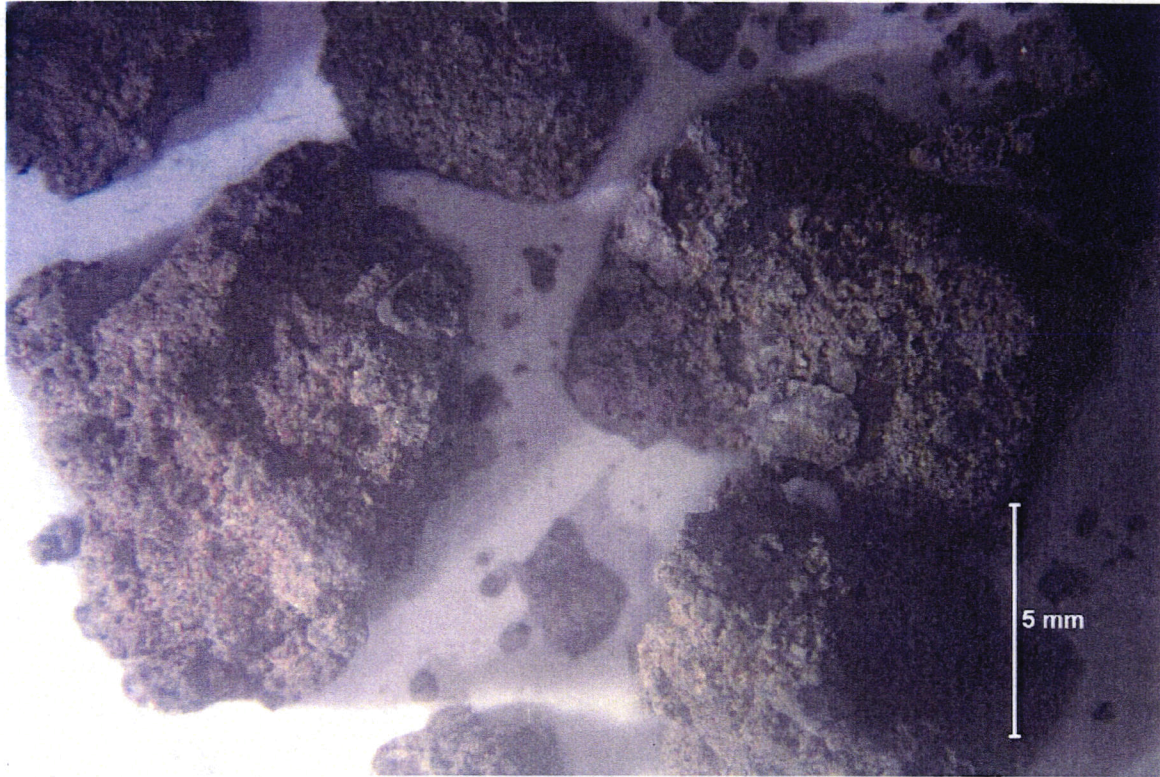
SAMPLE ID: Knife DESCRIPTION: Outer surfaces of concrete splatters removed from knife.

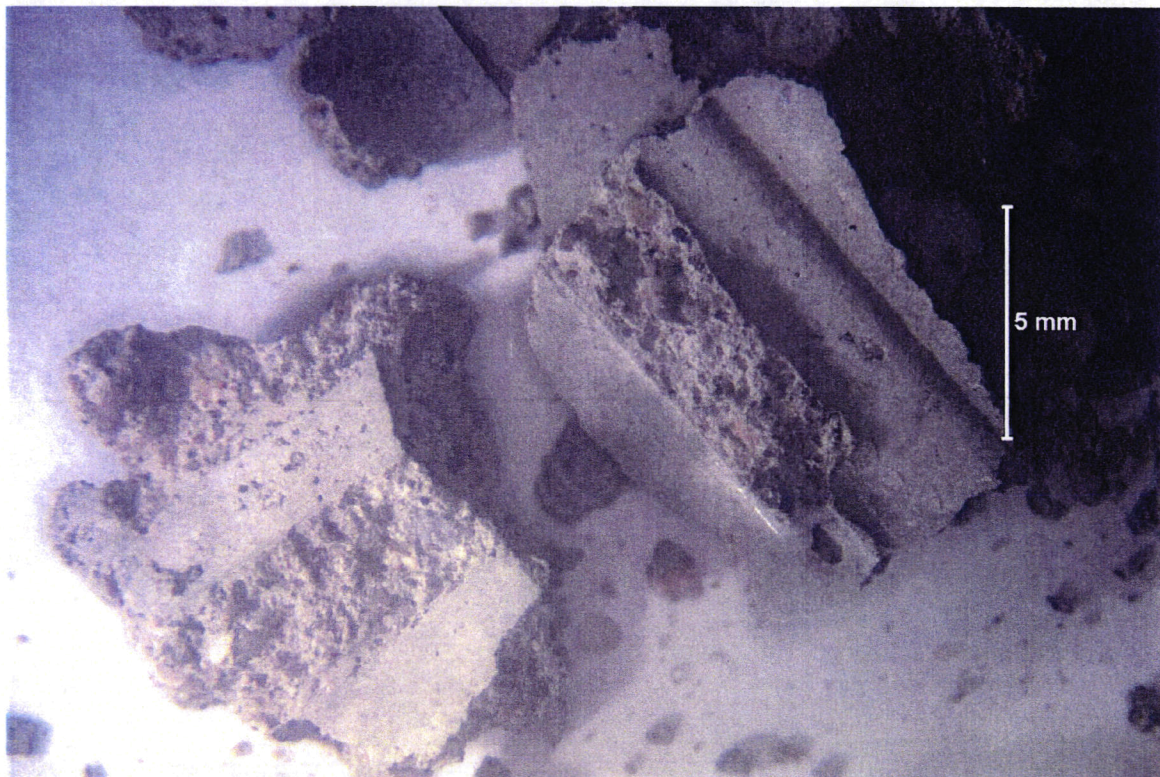
SAMPLE ID: Knife DESCRIPTION: Formed inner surfaces of concrete splatters removed from knife.

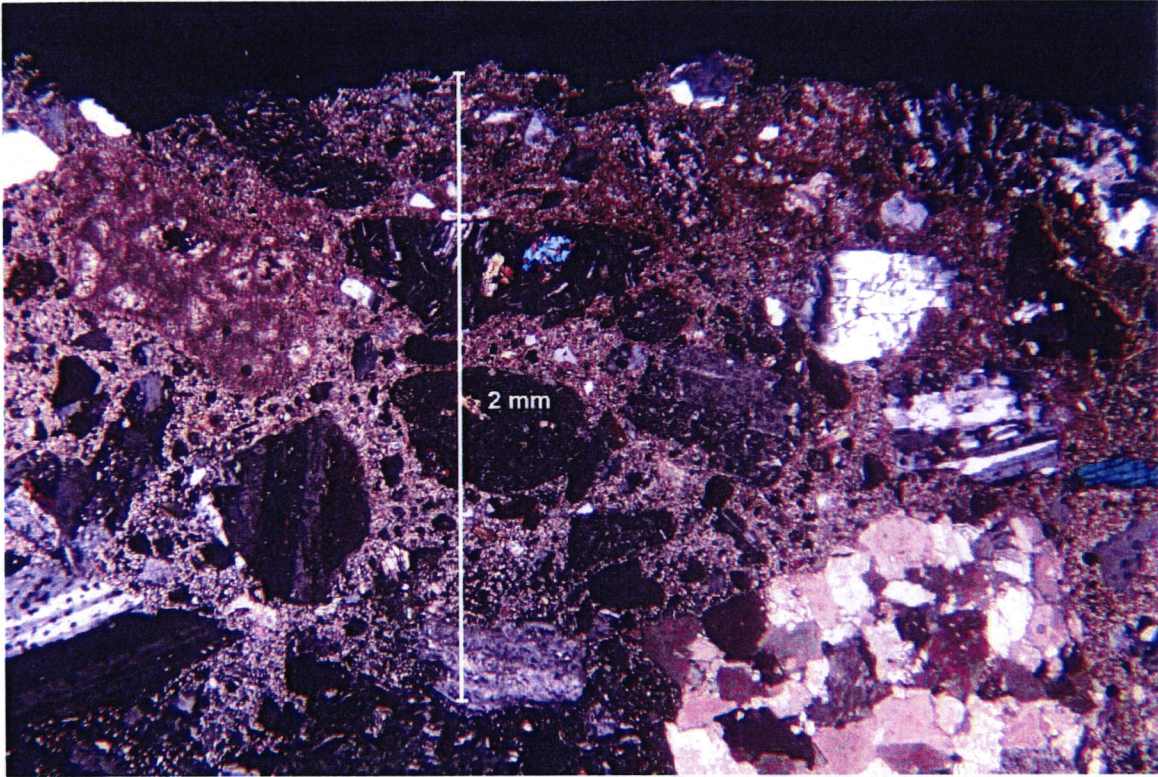
SAMPLE ID: P-2 DESCRIPTION: Carbonation (brightly colored) proceeds to 2mm depth from the victim leg impression (top) in thin section of concrete under cross polarized light.
MAG: 40x

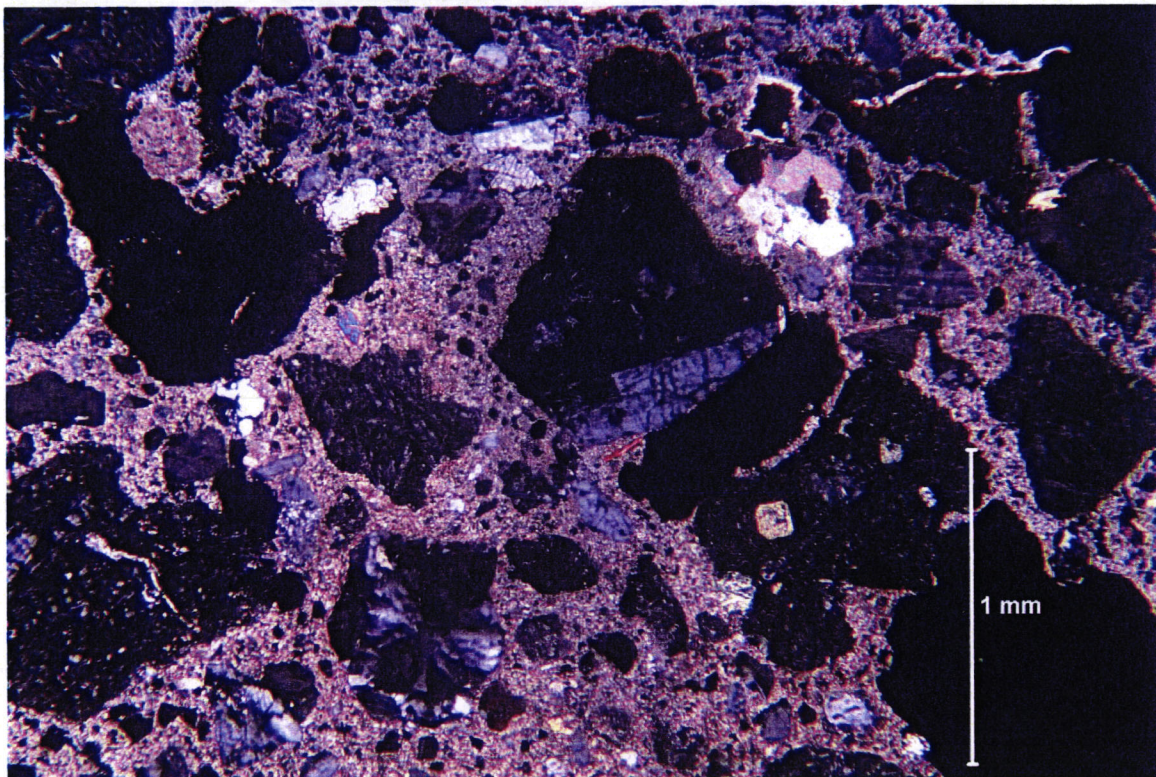
SAMPLE ID: P-3 DESCRIPTION: Carbonated (brightly colored) paste in thin section of concrete under cross polarized light.
MAG: 40x

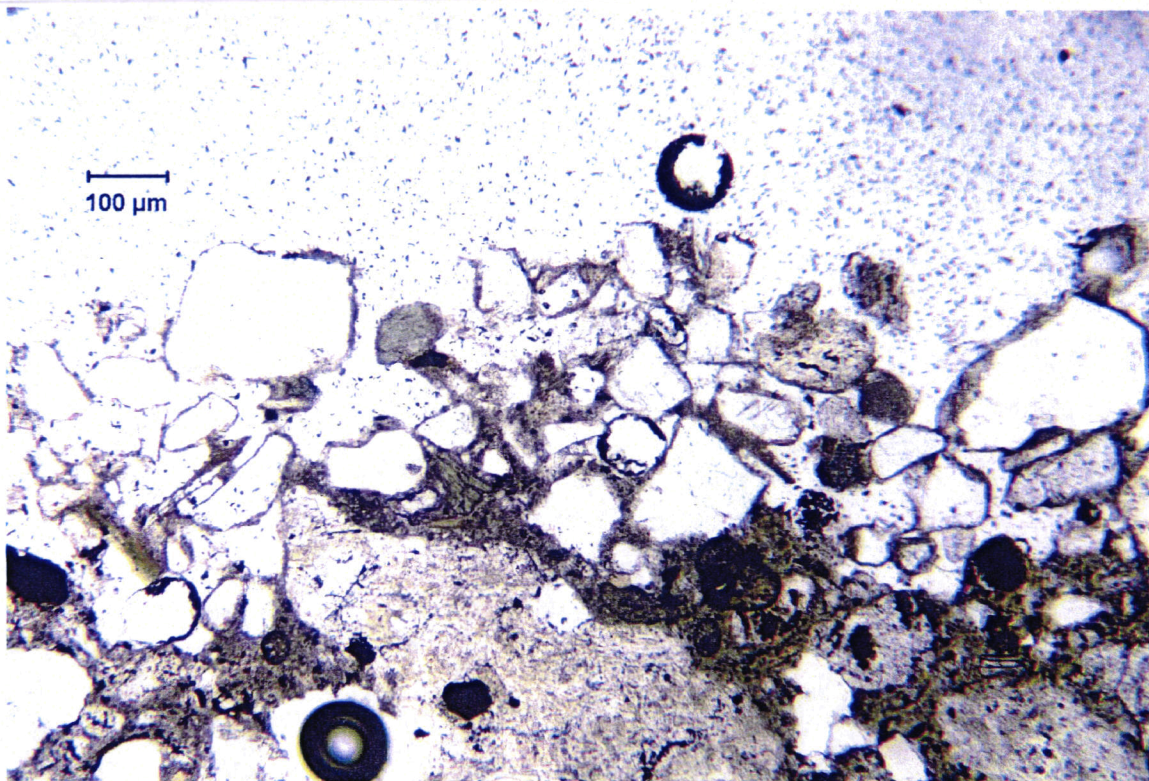
SAMPLE ID: Knife DESCRIPTION: Poorly cemented fine quartz and feldspar sand adhered (?) to the outer surface of a concrete splatter in thin section under plane polarized light.
MAG: 100x

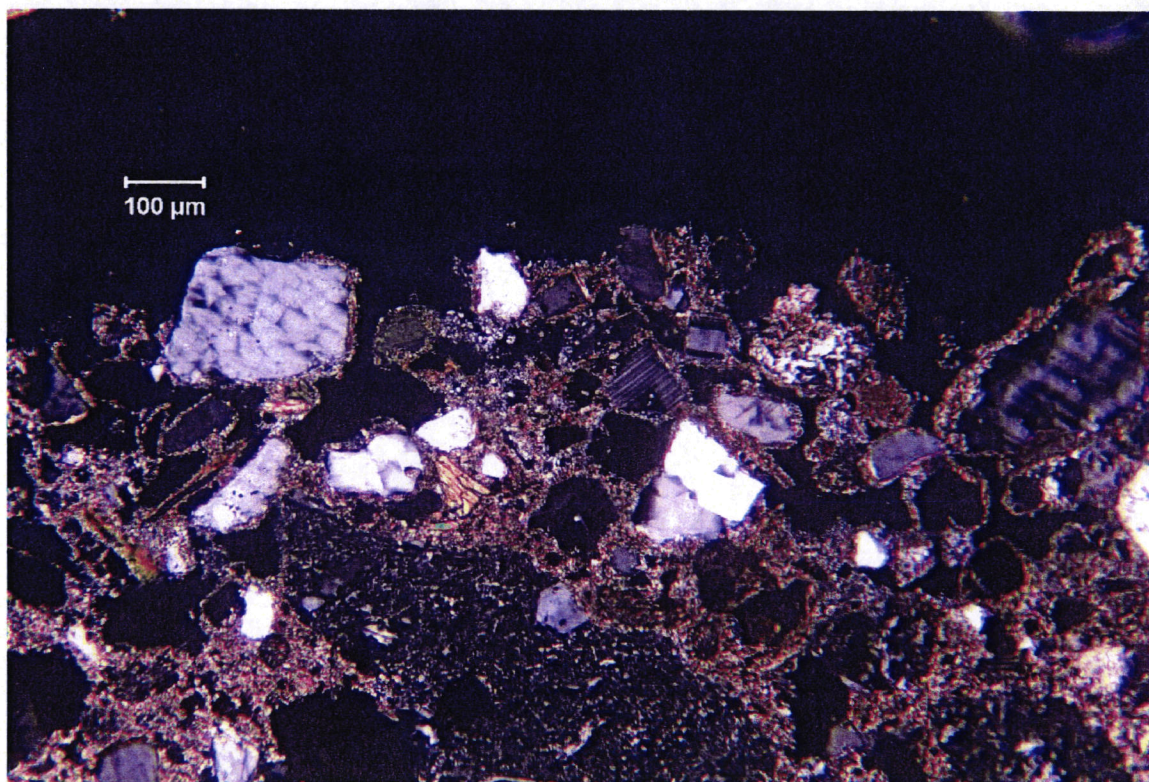
SAMPLE ID: Knife DESCRIPTION: Poorly cemented fine quartz and feldspar sand adhered (?) to the outer surface of a concrete splatter in thin section under plane polarized light.
MAG: 100x

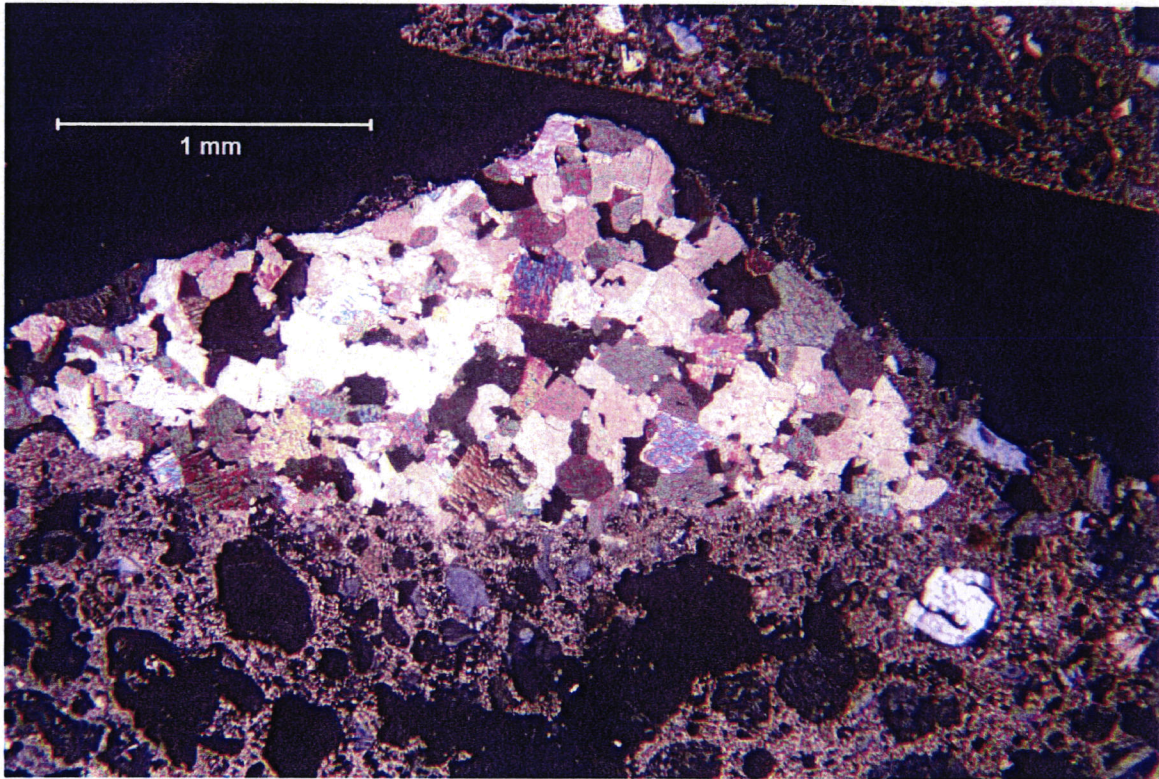
SAMPLE ID: Knife DESCRIPTION: Brightly colored carbonate particle in thin section of concrete splatter under cross polarized light.
MAG: 40x

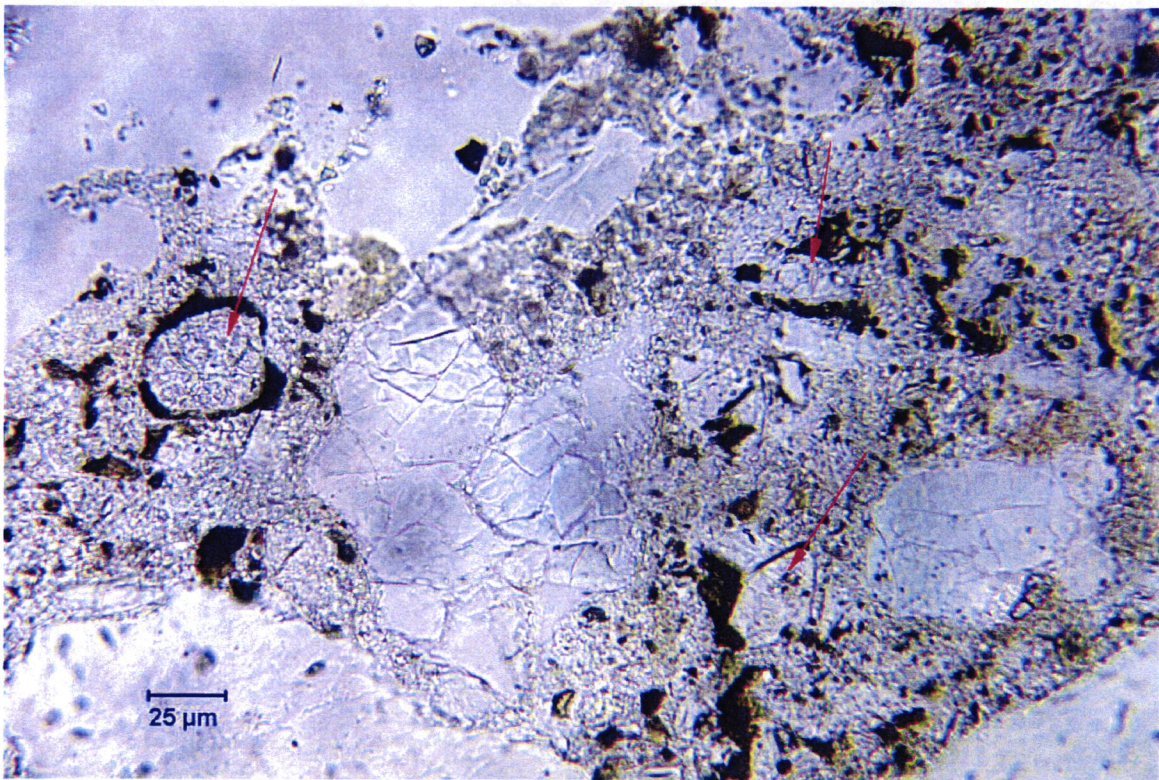
SAMPLE ID: Knife DESCRIPTION: Fully hydrated portland cement clinker relics in thin section of concrete splatter under cross polarized light.
MAG: 400x

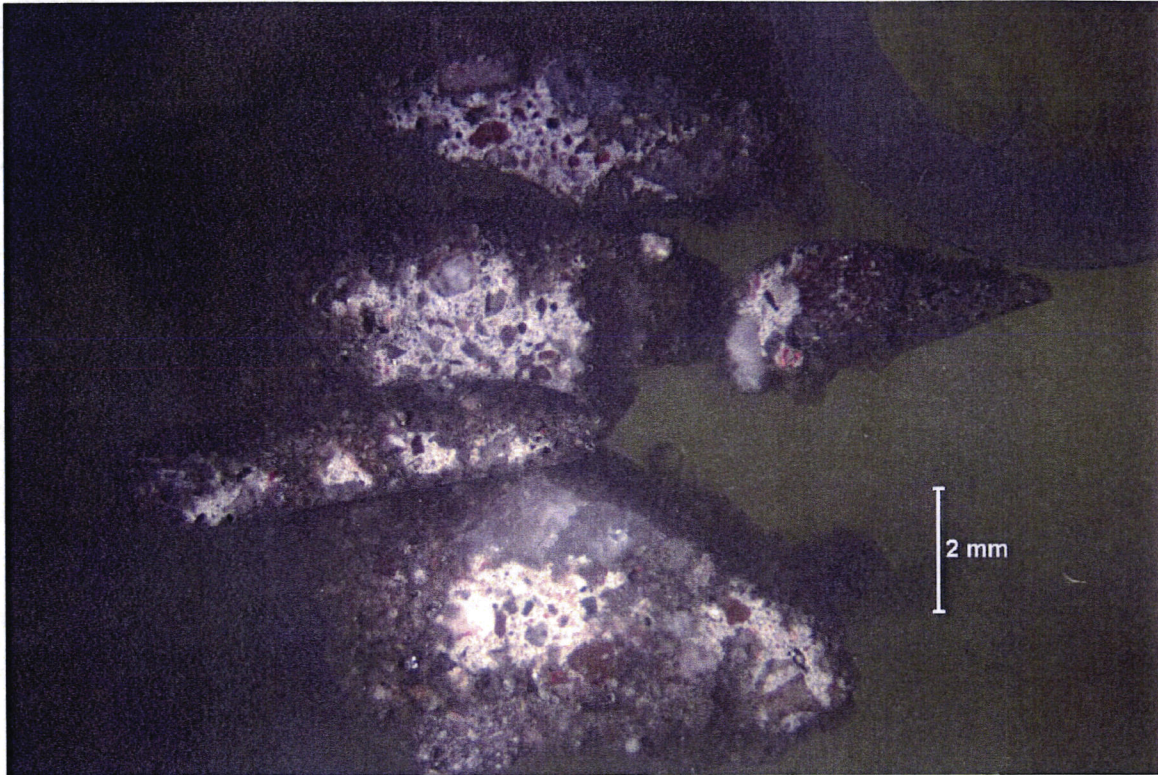
SAMPLE ID: Knife DESCRIPTION: Cross sections of epoxy-impregnated concrete splatters removed from knife.
