REPORT OF CONCRETE TESTING

LVMPD EVENTS #040215-1500

APS JOB NO: 10-03088

DATE: MAY 5, 2004

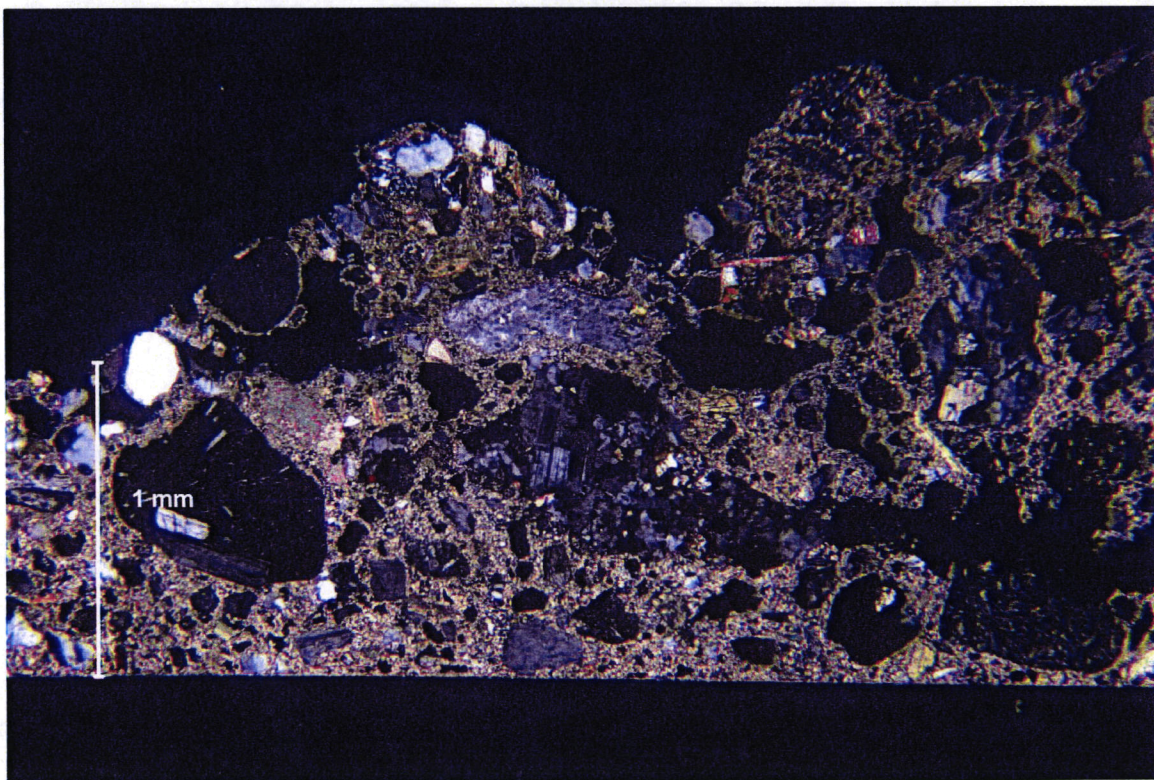
SAMPLE ID: Knife DESCRIPTION: Fully carbonated concrete splatter removed from knife, in thin section under cross polarized light. Smooth formed inner surface of splatter is at bottom of image.

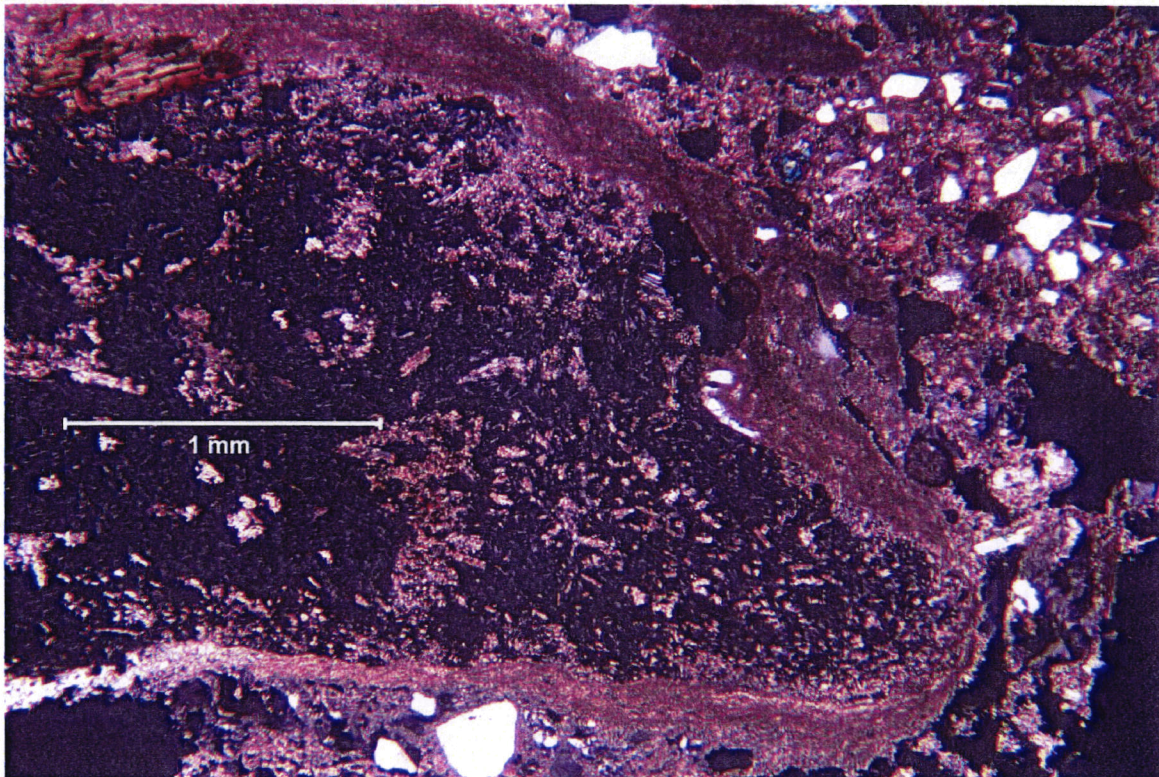
SAMPLE ID: P-1 DESCRIPTION: Carbonate coating a coarse aggregate particle incorporated in the concrete in thin section under cross polarized light.

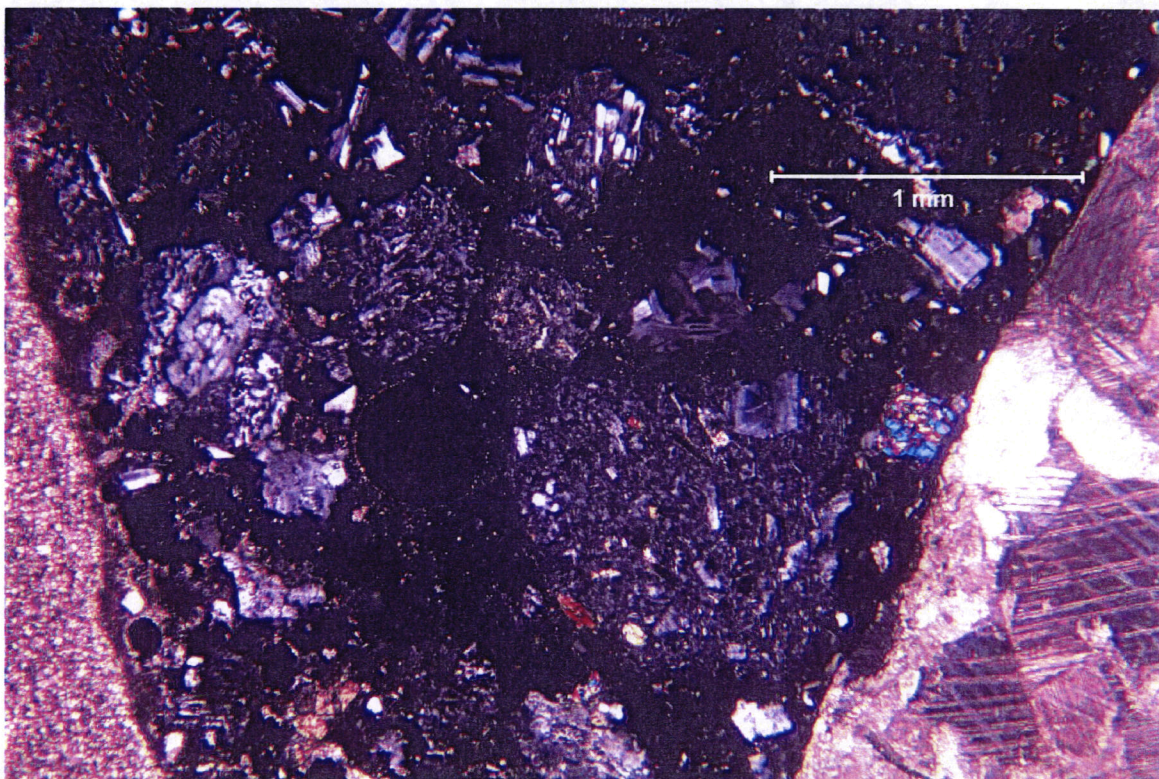
SAMPLE ID: P-1 DESCRIPTION: Mafic extrusive volcanic fine aggregate particles in thin section of concrete under cross polarized light. Note brightly colored carbonate coarse aggregate particles at left and right side of image.

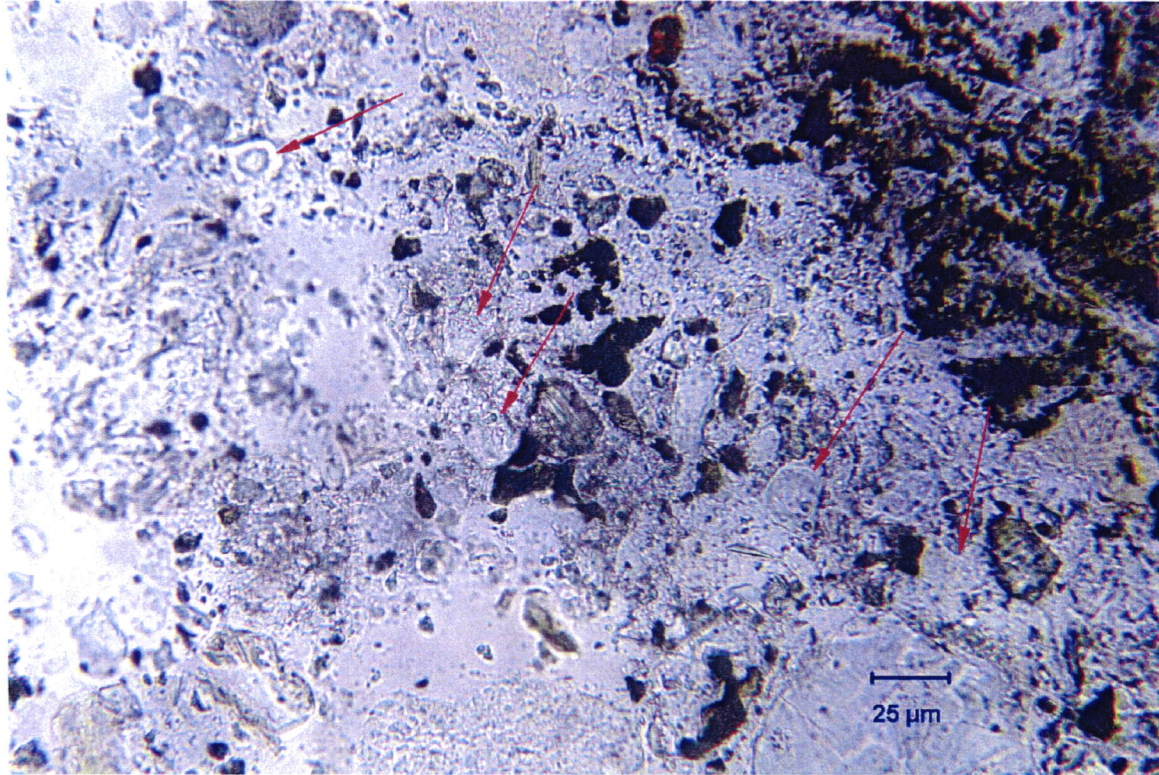
SAMPLE ID: P-2 DESCRIPTION: Well to fully hydrated portland cement clinker particles in thin section of paste under plane polarized light.
MAG: 400x

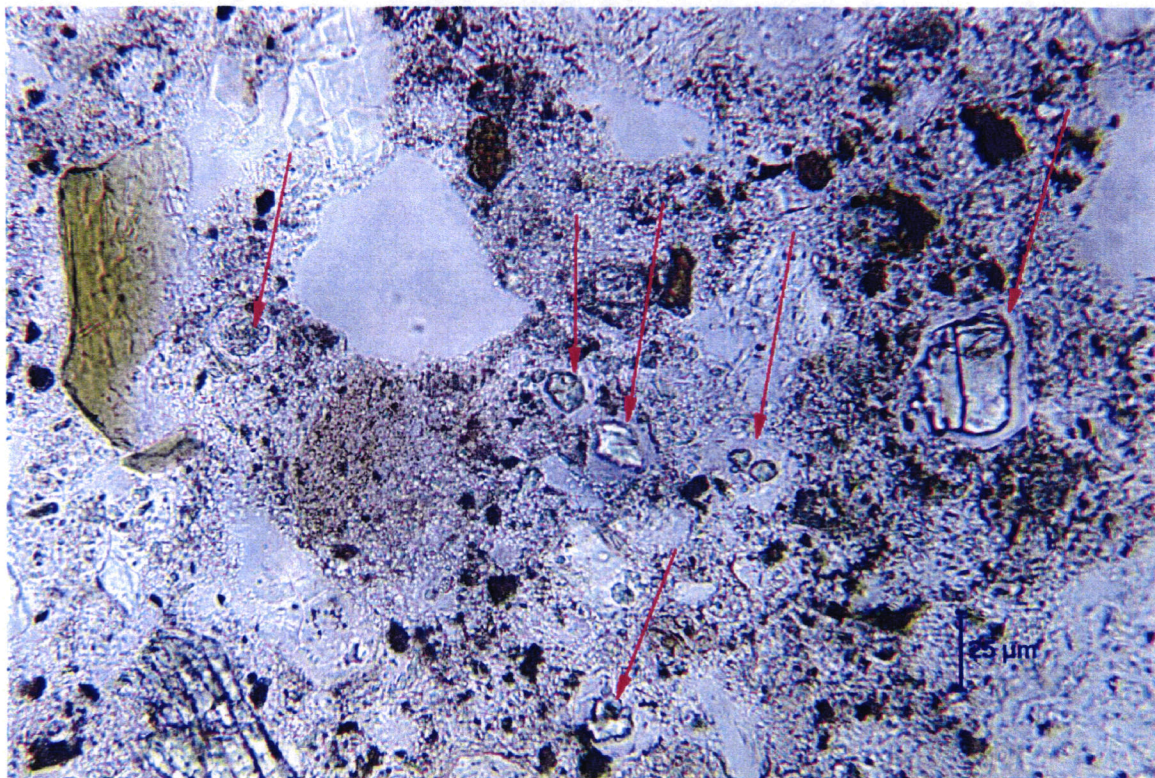
SAMPLE ID: P-3 DESCRIPTION: Well hydrated portland cement clinker particles in thin section of paste under plane polarized light.
MAG: 400x

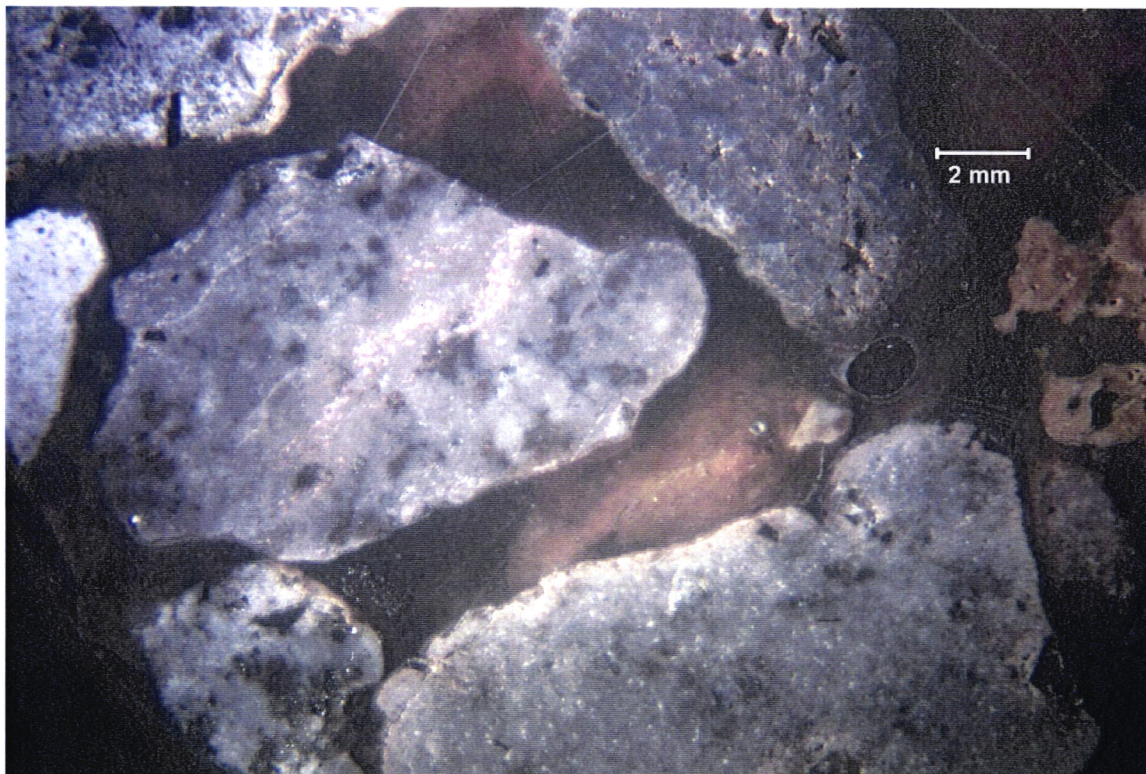
SAMPLE ID: Crime Scene Material DESCRIPTION: Overall view of the basalt aggregate in polished cross section of material retained on the #4 sieve.
MAG: 7.5x

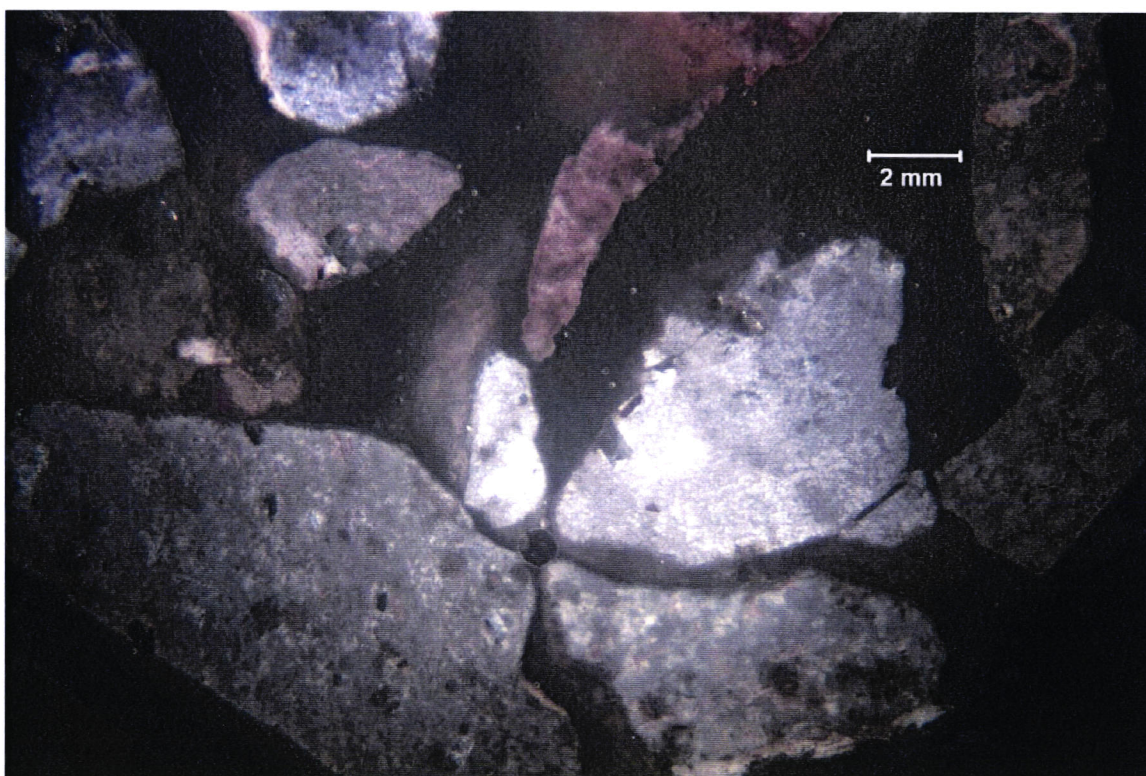
SAMPLE ID: Crime Scene Material DESCRIPTION: Another overall view of the basalt aggregate in polished cross section of material retained on the #4 sieve.
MAG: 7.5x

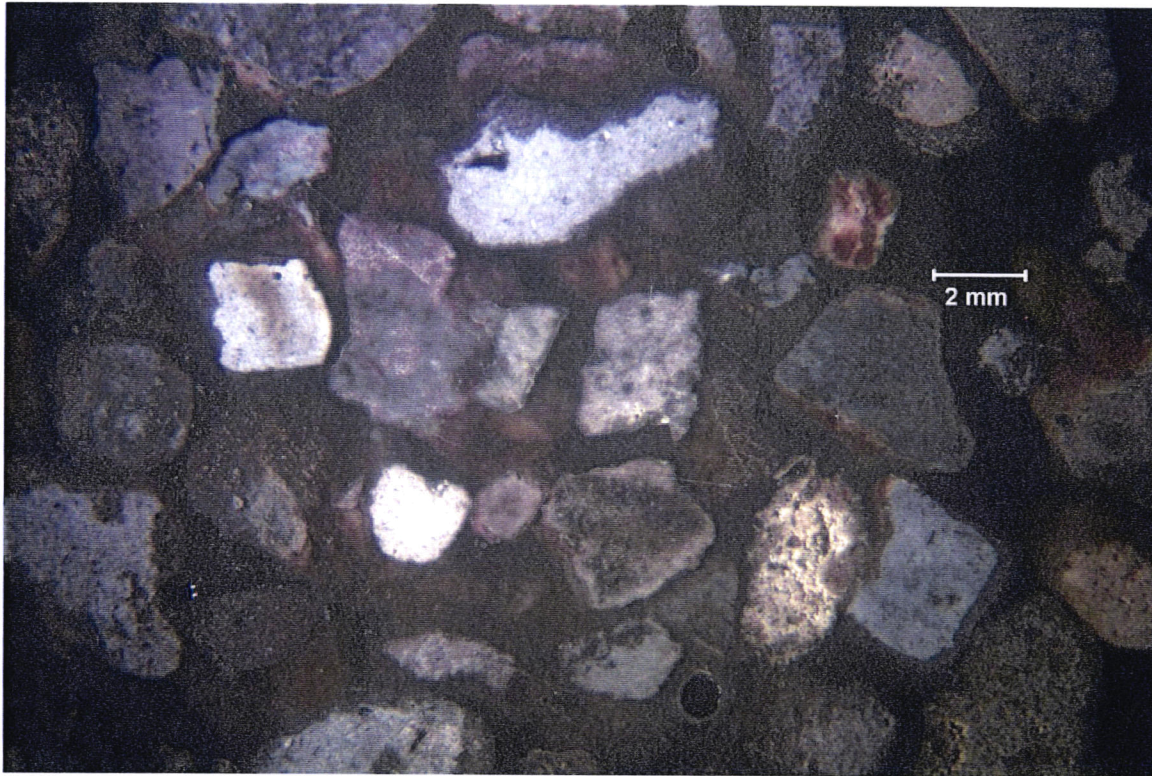
SAMPLE ID: Crime Scene Material DESCRIPTION: Overall view of the basalt-rich aggregate in polished cross section of material retained on the #8 sieve.
MAG: 7.5x

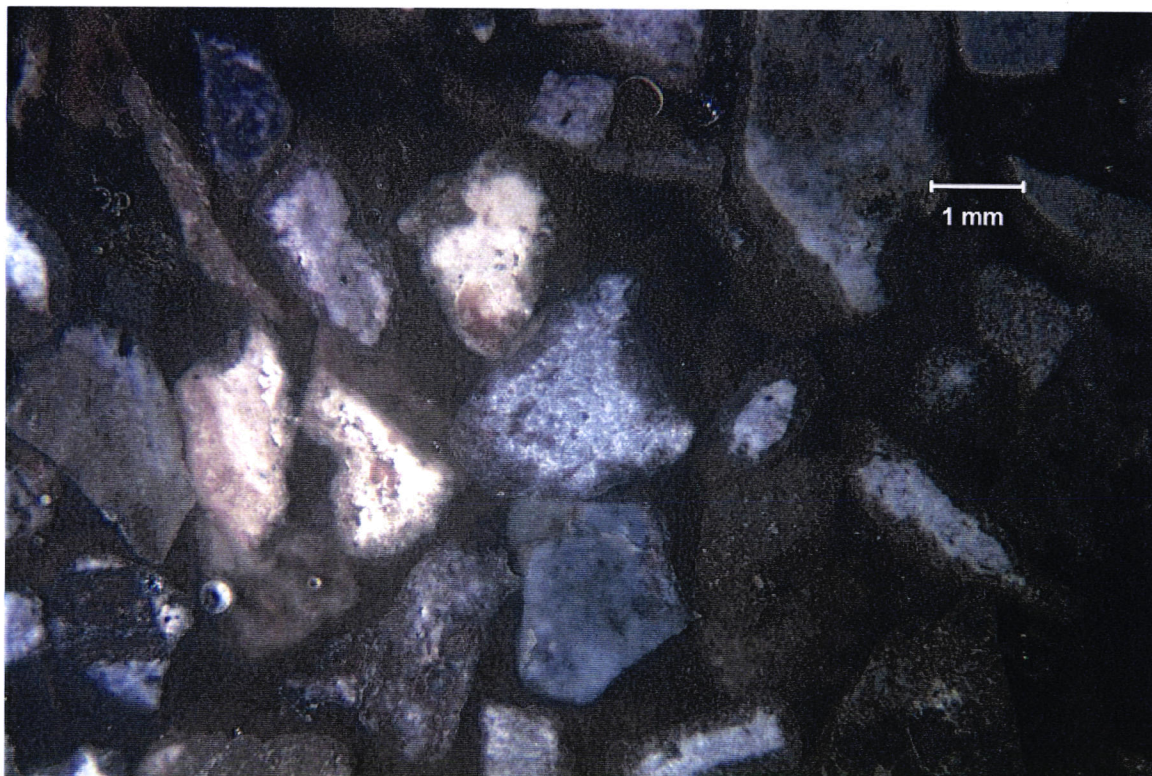
SAMPLE ID: Crime Scene Material DESCRIPTION: Overall view of the basalt-rich aggregate in polished cross section of material retained on the #16 sieve.
MAG: 15x

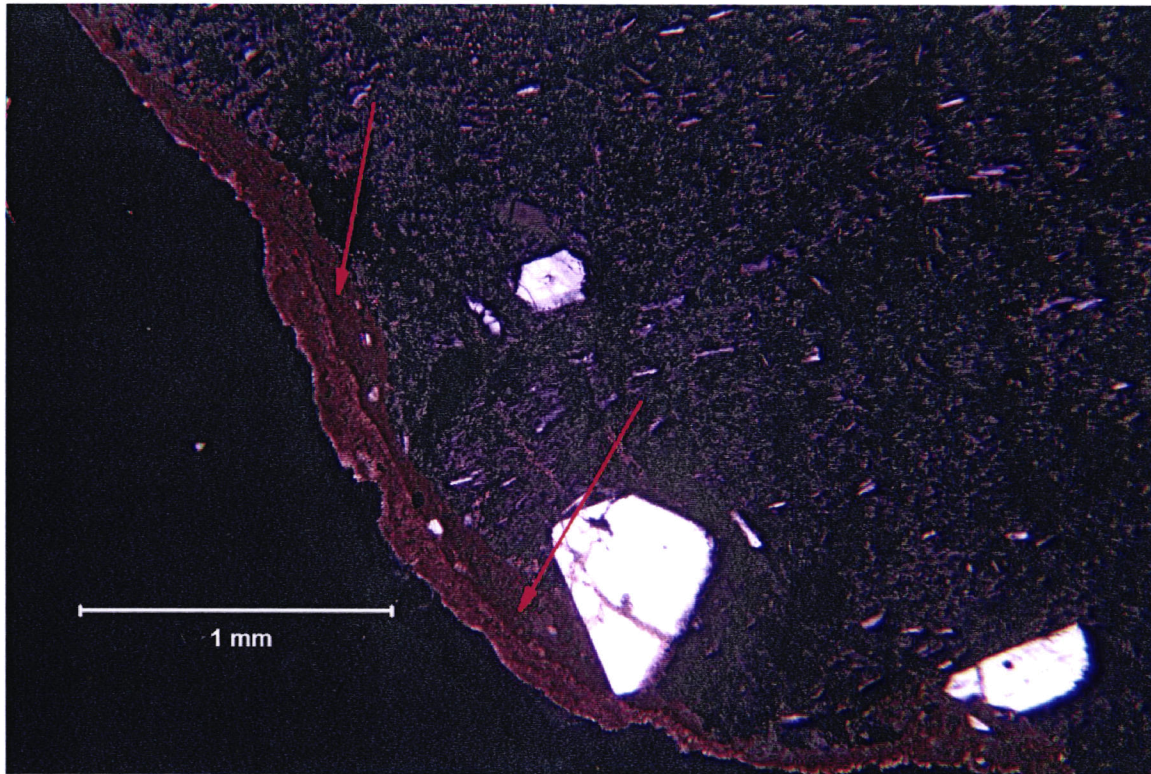
SAMPLE ID: Crime Scene Material DESCRIPTION: A calcite coated basalt particle in thin section of material retained on the #4 sieve under cross polarized light. The calcite is marked by red arrows.
MAG: 40x

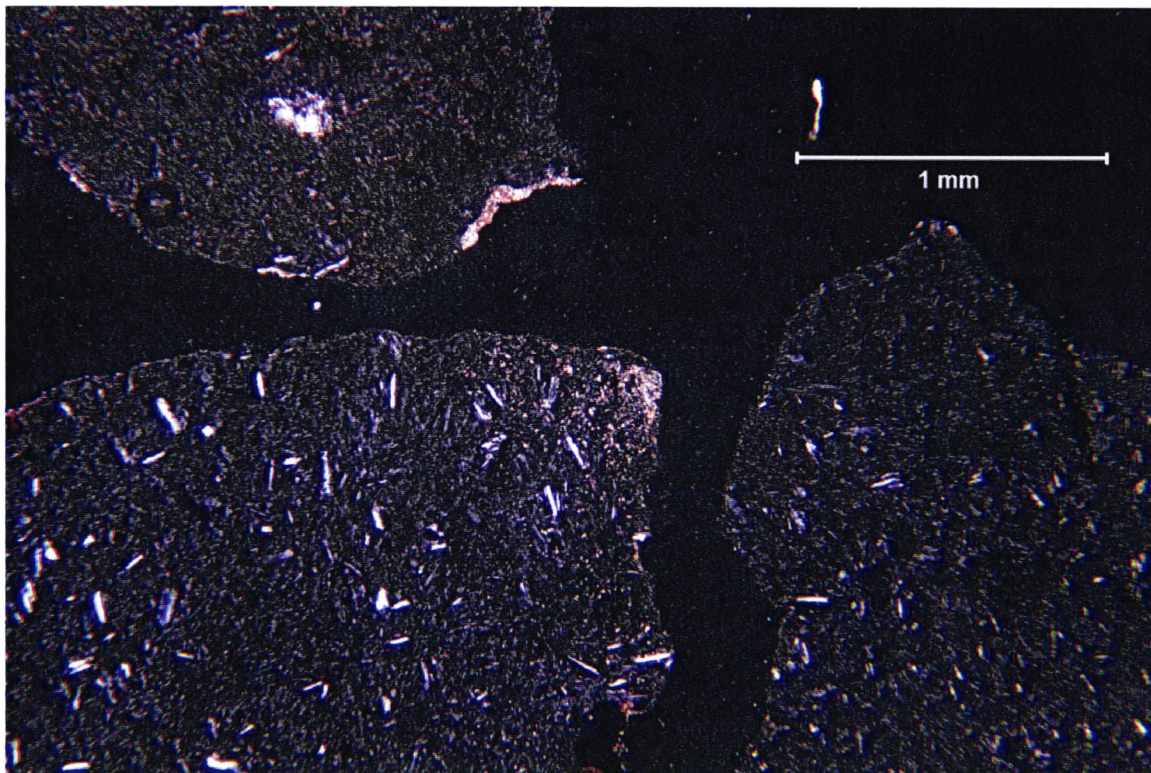
SAMPLE ID: Crime Scene Material DESCRIPTION: Three basalt aggregate particles in thin section of material retained on the #8 sieve under cross polarized light.
MAG: 40x

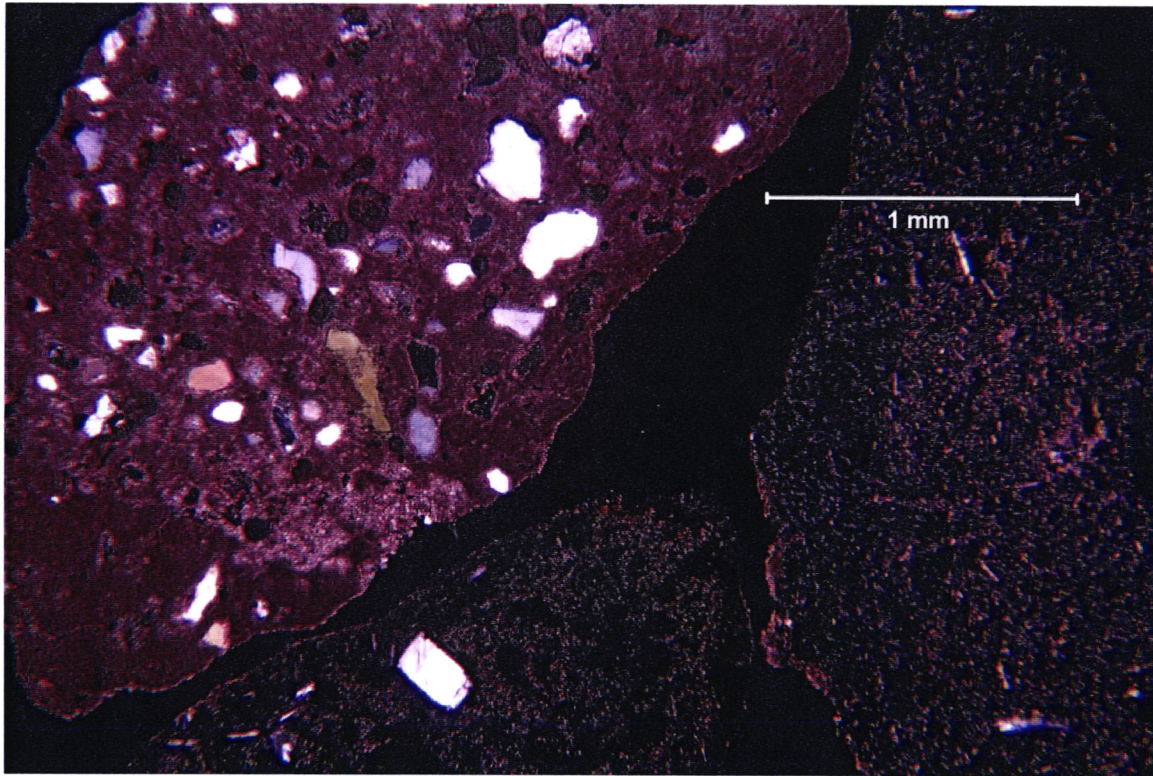
DESCRIPTION: A calcite and two basalt particles in thin section of material retained on the #16 sieve under cross polarized light. The calcite contain bright quartz sand particles.

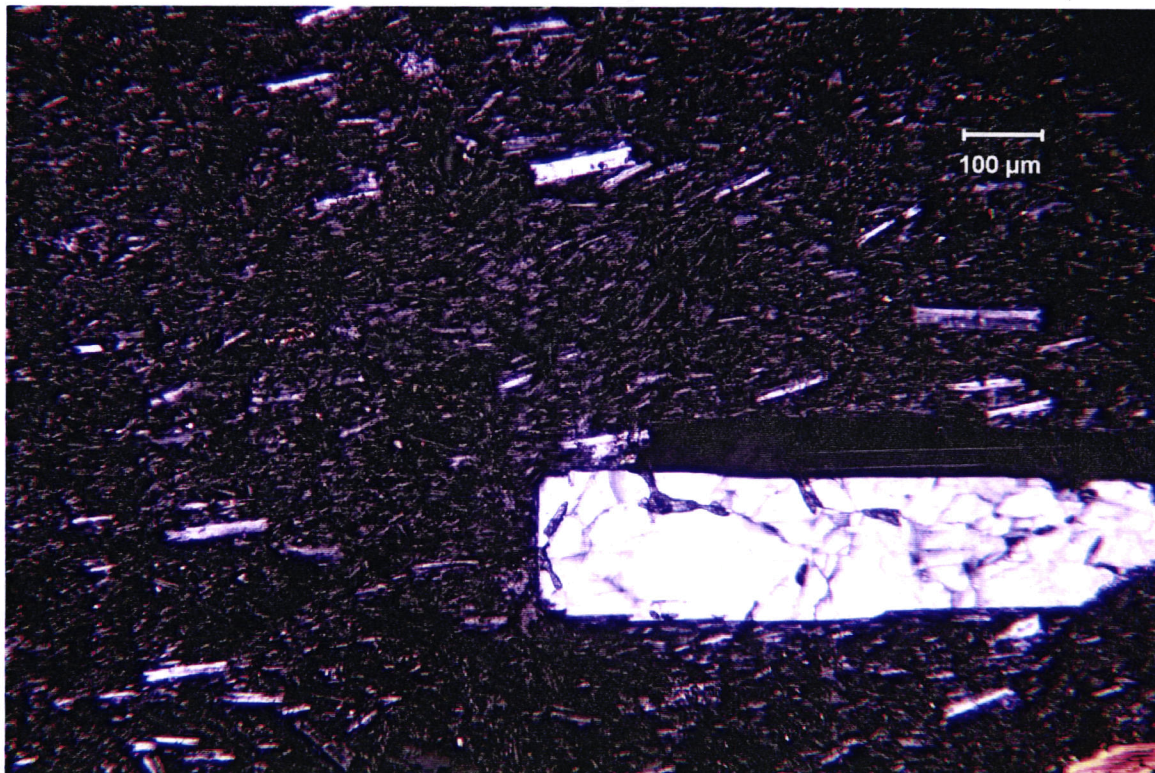
DESCRIPTION: The basalt aggregate particles contain lineated phenocrysts and ground mass (trachytic texture) in thin section under cross polarized light.
